Manhole Inspection Summary

Manhole # S11Y__021MH

Insp Date: **4/7/08 1:10 PM**

Location Address: **3309 Bebson Ave**

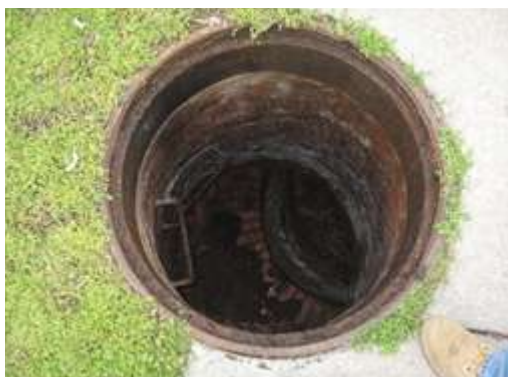
Defect 1

Steps Count: **3** Missing: **0** ☒ Corroded

corroded steps

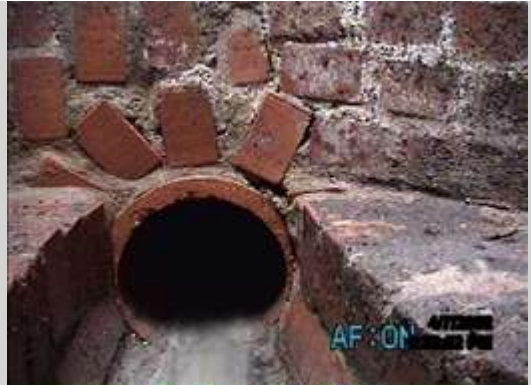
12 O'Clock Outflow

8 in. Circular Gravity Sewer
Pipe Out @ 12 O'Clock

Pipe Height: **8.4** (in.) Rod and Bar (Angled)
Pipe Material: **Clay** ☐ Pipe Lined
Invert Depth: **8.44** (ft.) Flow Characteristics: **Fast**
Deposits: ☒ None ☐ Mud ☐ Sludge ☐ Debris ☐ Grease
Silt Depth: **0** (in.) Deposits Extent:
Infiltration: **None** Pipe Seal Cond: **Sound**

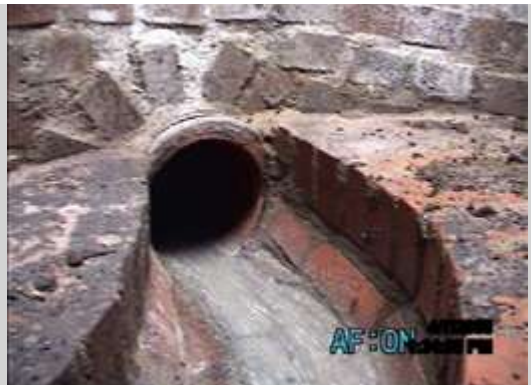
4 O'Clock Inflow

8 in. Circular Gravity Sewer
Pipe In @ 4 O'Clock

Pipe Height: **8.4** (in.) Rod and Bar (Angled)
Pipe Material: **Clay** ☐ Pipe Lined
Invert Depth: **8.65** (ft.) Flow Characteristics: **Fast**
Deposits: ☒ None ☐ Mud ☐ Sludge ☐ Debris ☐ Grease
Silt Depth: **0** (in.) Deposits Extent:
Infiltration: **None** Pipe Seal Cond: **Sound**
